**No.** 2006-06(W)

**MODELS:** 2007 Evinrude® E-TEC® 60°V4  
115 HP Models

**SUBJECT:** Engine Software Update

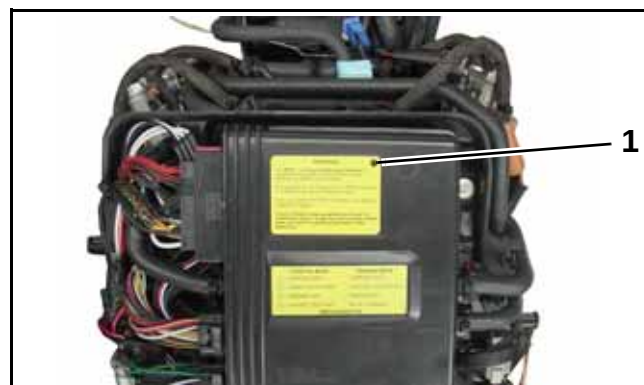
1. Mark

Remove the engine cover and inspect EMM for software update as shown. If the marking is present in the location shown, the update software has already been installed.
